MARTHA'S VINEYARD WATERSHEDS

Martha's Vineyard Watersheds

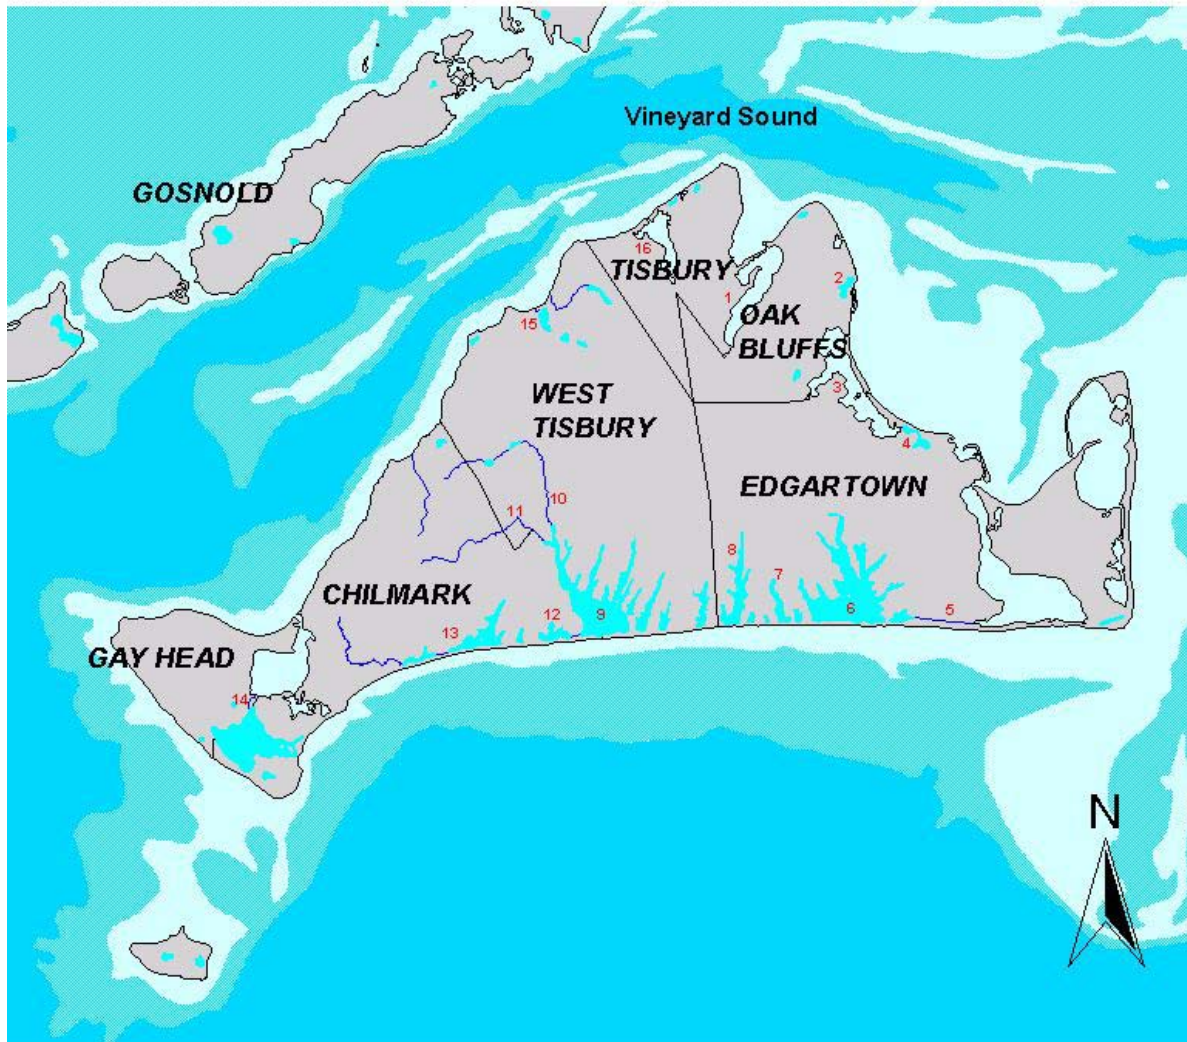
Major Streams and Ponds of Martha's Vineyard

| 1 - Lagoon Pond | 9 - Tisbury Great Pond |
| 2 - Farm Pond | 10 - Mill Brook |
| 3 - Sengekontacket Pond | 11 - Tiasquam River |
| 4 - Trapps Pond | 12 - Black Point Pond |
| 5 - Mattakeset Herring Creek | 13 - Chilmark Pond |
| 6 - Edgartown Great Pond | 14 - Gay Head Herring Creek |
| 7 - Jobs Neck Pond | 15 - James Pond |
| 8 - Oyster Pond | 16 - Lake Tashmoo |

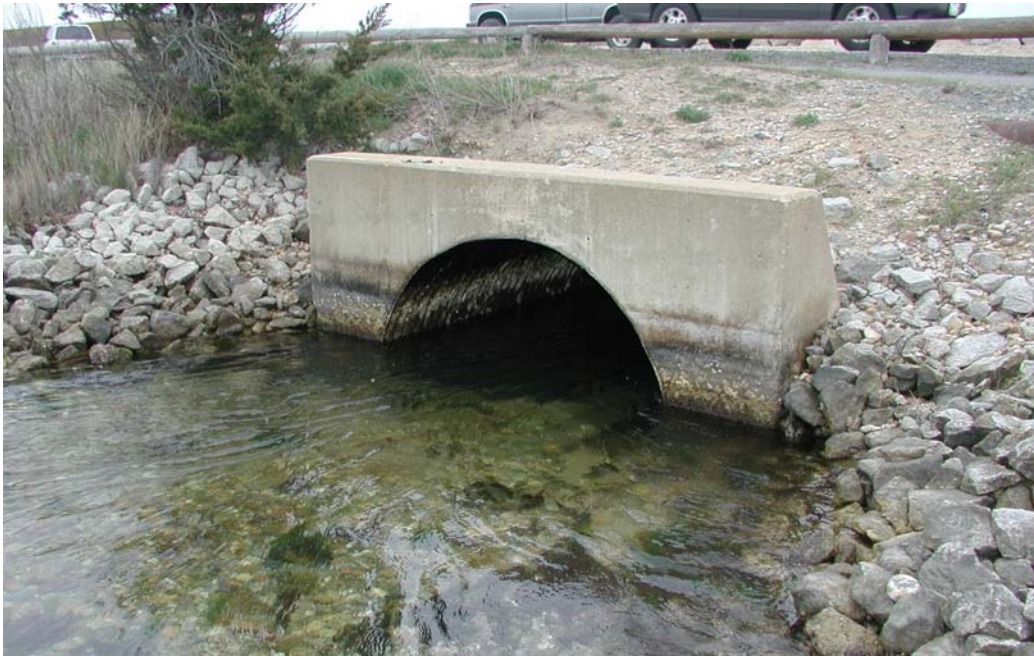
Farm Pond Outlet

This 33 acre salt pond is connected to Vineyard Sound by a 6 foot diameter culvert. The high salinities which occur in the pond eliminate any possibility of development for anadromous fish.

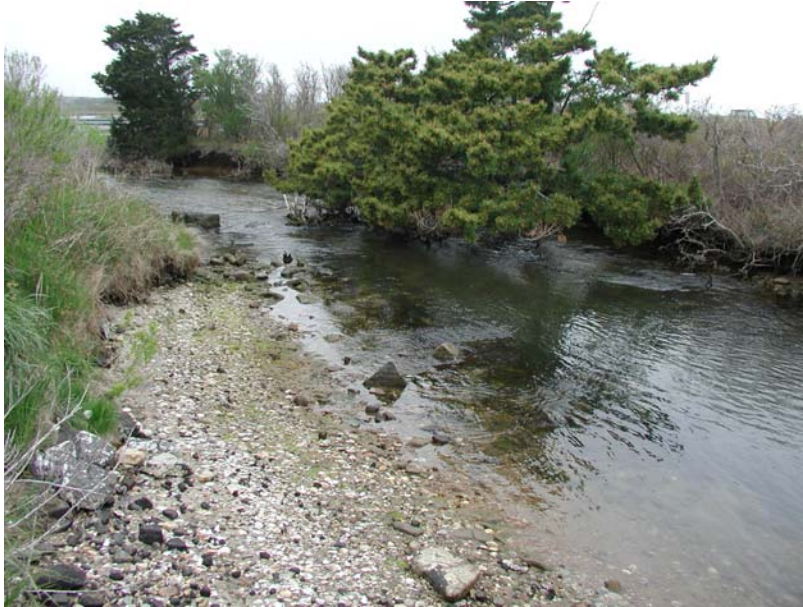
Outlet of Trapps Pond

Forty four acre Trapps Pond is connected to Sengekontacket Pond by a short tidal creek. Salinities are high and, although herring have been reported here, there is little opportunity for development.

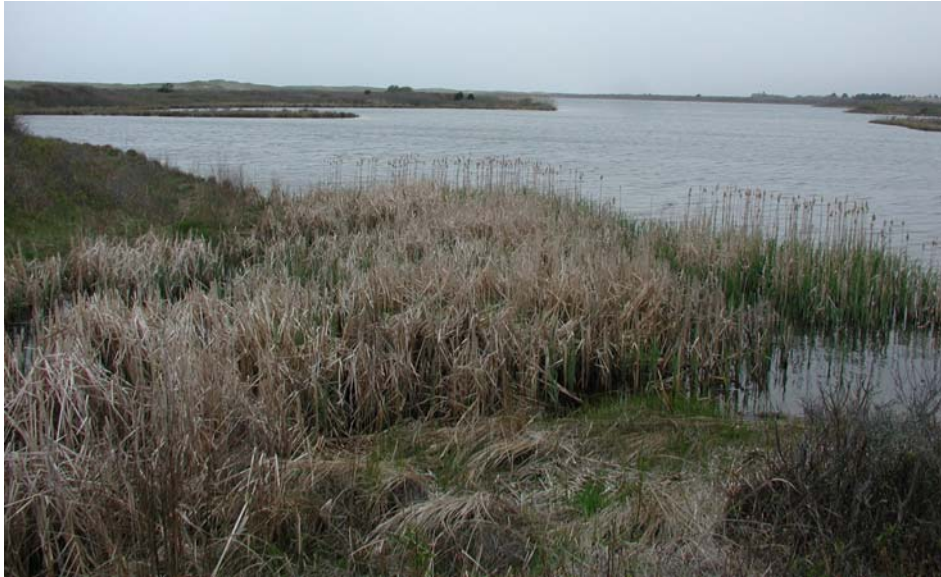
Mattakeset Herring Creek

This long artificial ditch, excavated in 1889, connected Edgartown Great Pond, an 1157 acre salt pond, to Katama Bay by way of Crackatuxet Cove. This access to the Great Pond enabled the establishment of a productive, private alewife fishery. In more recent years the connection between Crackatuxet Cove and Edgartown Great Pond has filled in and, with no passage available and little flow down the creek, the run no longer exists.

The Town of Edgartown with the cooperation of state and Federal agencies and NGOs has proposed to reestablish the connection with a control structure that will allow regulation of salinities within Crackatuxet Cove and provide restored spawning habitat in this 38 acre pond. This in combination with the extended opening of Edgartown Great Pond and dredging of the approach from Katama Bay should allow a new population to become established providing salinities in pond can be kept within an acceptable range for spawning and survival.

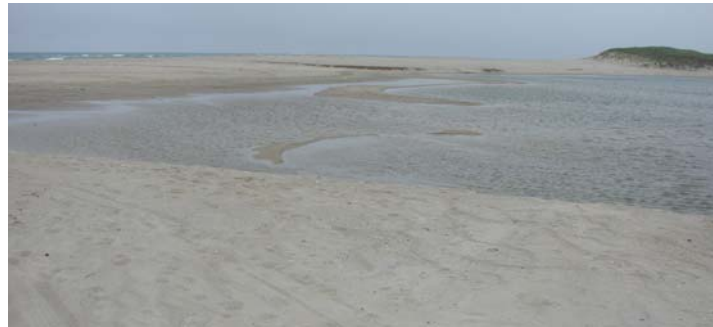
Barrier Beach at Edgartown Great Pond

River Mile	Type	Material	Spillway W (ft)	Spillway H (ft)	Pond Acreage	Year Built	Owner	GPS
0.0	Barrier beach	-	-	-	1157.	-	-	N/A

This large salt pond is opened to the sea annually in order to maintain salinity for shellfish propagation. Salinities are low enough to allow some river herring reproduction. How the proposed extended opening of the outlet to the sea for the purpose of improved shellfish production will affect this population is unknown. A restored population in Crackatuxet Cove, however, should offset any reduction in size brought on by increased salinities in the Great Pond.

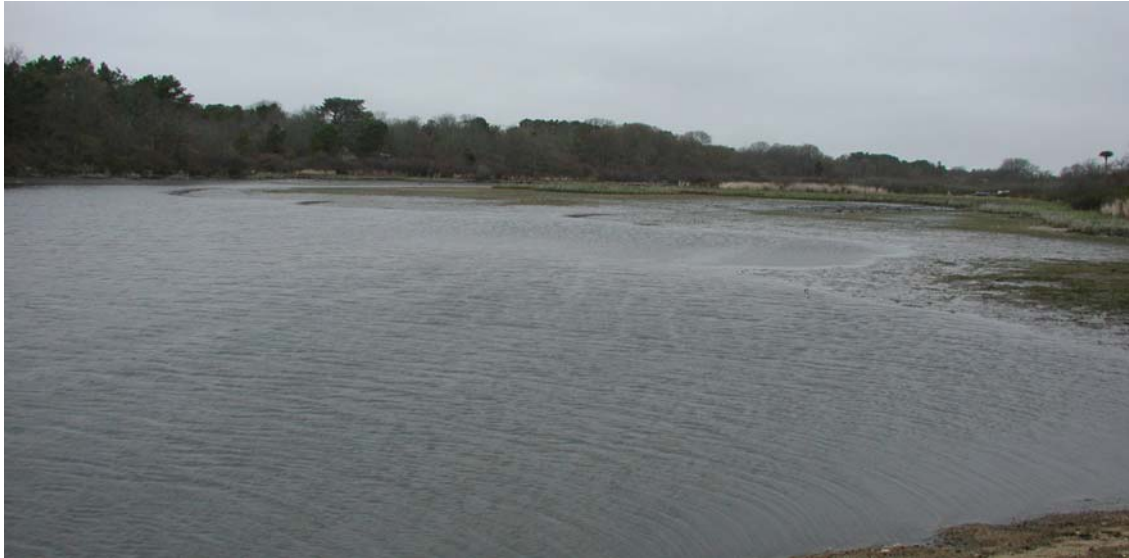
Oyster Pond was once opened on an annual basis and supported a commercial fishery. The town continues this practice but there is no way to significantly improve the anadromous fish resource here.

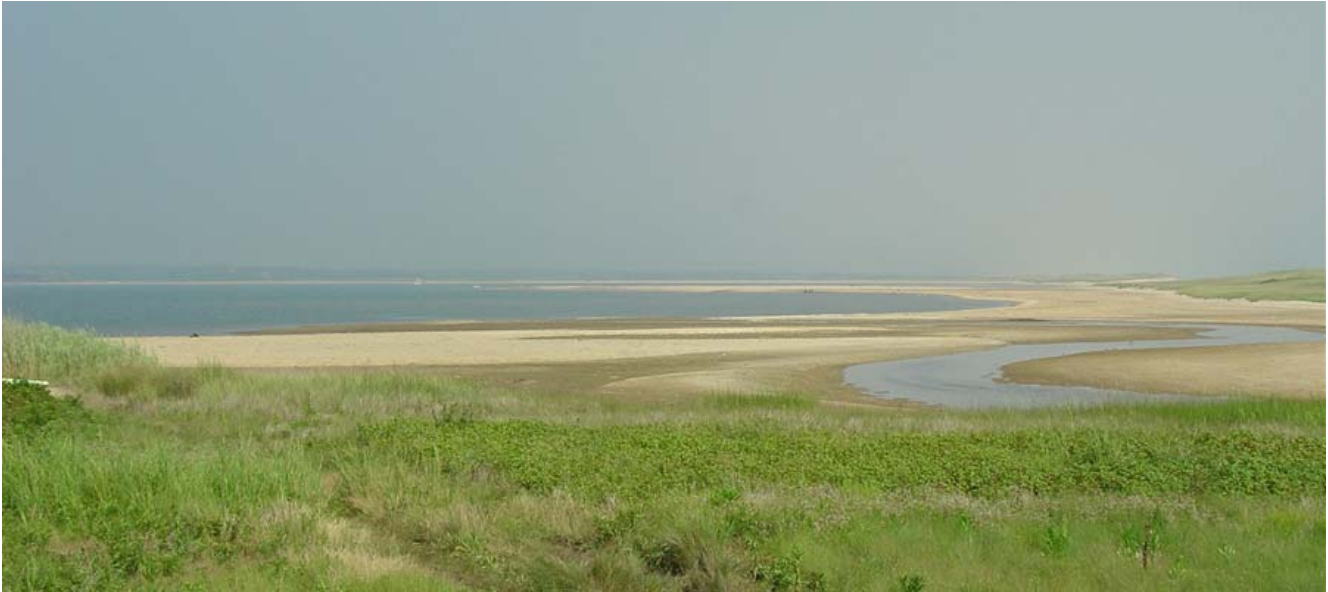
River herring access to Tisbury Great Pond is dependent upon annual opening of the barrier beach. Freshwater input from two feeder streams maintains salinity levels in the upper portion of the pond that are conducive to spawning and survival. The 915 acres of habitat have supported a productive commercial fishery in the past.

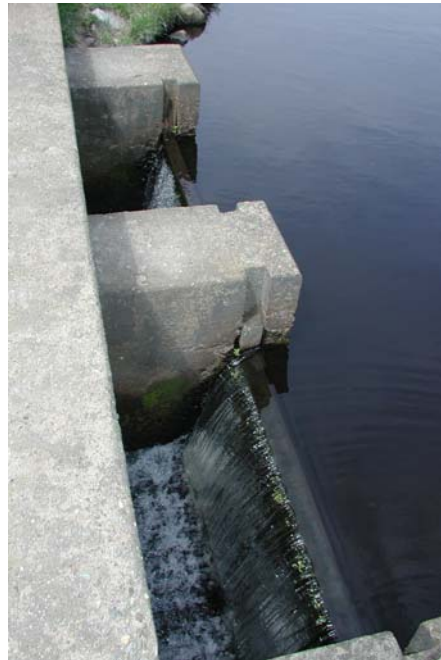
Spillway at Old Millpond Dam

River Mile	Type	Material	Spillway W (ft)	Spillway H (ft)	Impoundment Acreage	Year Built	Owner	GPS
0.4	Dam	Concrete with wooden boards	10.0	2.0	2.0	1890	Town of West Tisbury	41° 22' 58.109" N 70° 40' 17.500" W

This tributary to Tisbury Great Pond has a number of small impoundments. The acreage available in these impoundments is insignificant compared to that provided by the Great Pond. As a result, the expense of providing passage at each dam is not justified.

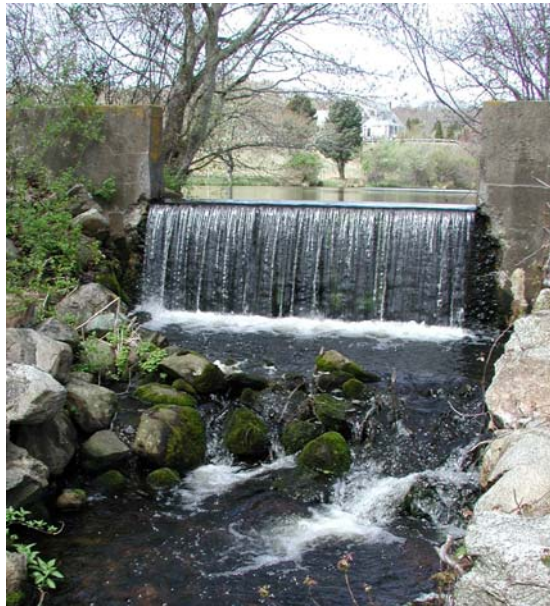
Looks Pond Dam

River Mile	Type	Material	Spillway W (ft)	Spillway H (ft)	Impoundment Acreage	Year Built	Owner	GPS
0.6	Dam	Concrete and stone	10.0	5.6	4.6	-	Private	41° 22' 40.814" N 70° 40' 44.601" W

Another tributary to Tisbury Great Pond, Tiasquam River flows through several small impoundments. As with Mill Brook, the benefits to be gained in terms of total population increase by constructing a fishway here are limited and likely costly.

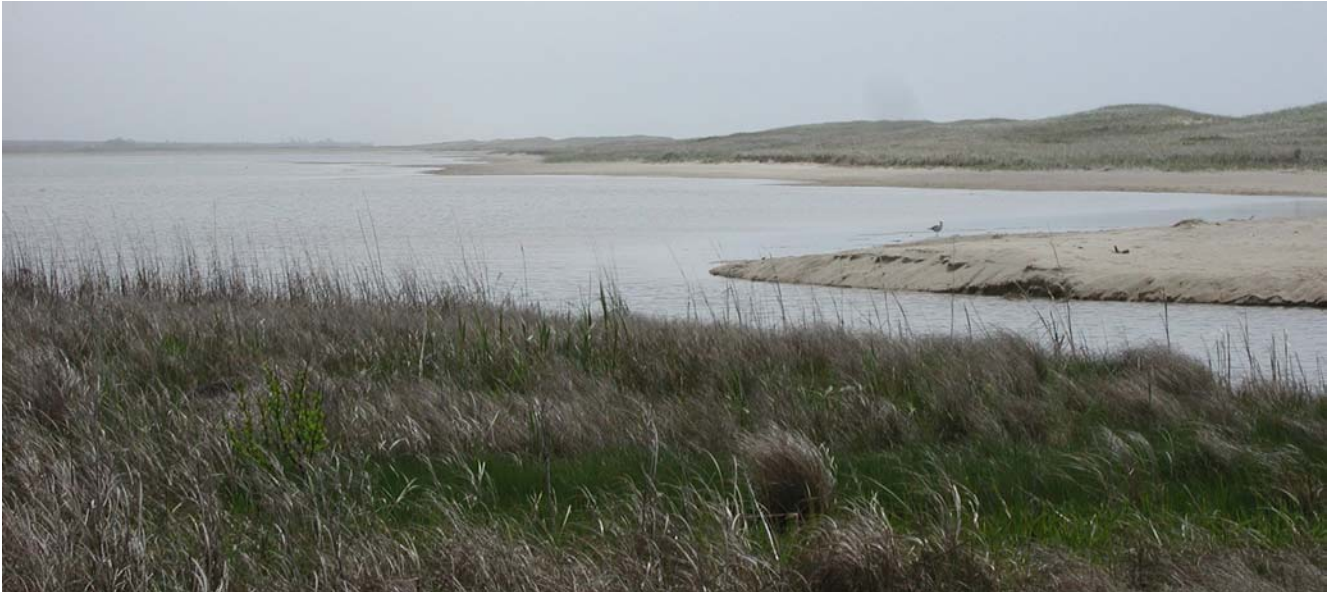
Outlet of Black Point Pond

Alewives have access to this 65 acre brackish pond from Tisbury Great Pond via a 1200 foot man made ditch. It is not known how much this pond contributes to the production of the system. In the past a commercial white perch fishery was carried on here.

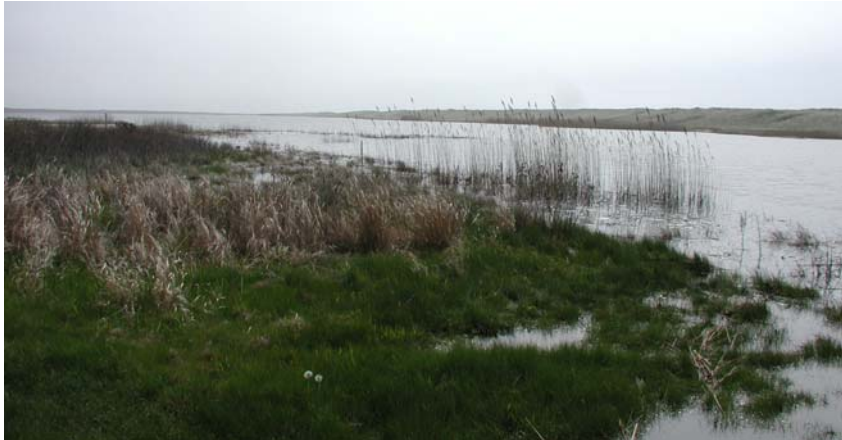
Chilmark Pond is a 221 acre salt pond which once supported a productive white perch fishery and a smaller alewife fishery. The Pond is artificially opened to raise salinity for shellfish propagation and allow alewife passage.

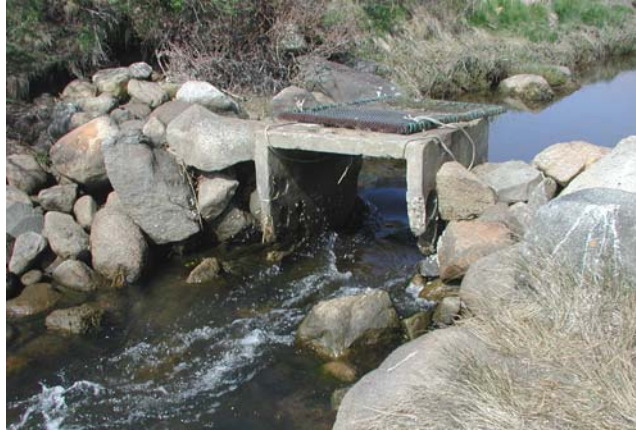
Outlet of Gay Head Herring Creek

This artificial stream connects Squibnocket Pond to Menemsha Pond, a large tidal inlet. River herring enter Menemsha Pond from Vineyard Sound and ascend the stream to the 604 acre headwater pond. An active fishery is maintained and conducted by the Wampanoag tribe of Aquinnah, formerly the town of Gay Head, who have legal control of this resource. Other than shoaling of the stream mouth, this system functions well and there is little room for further development.

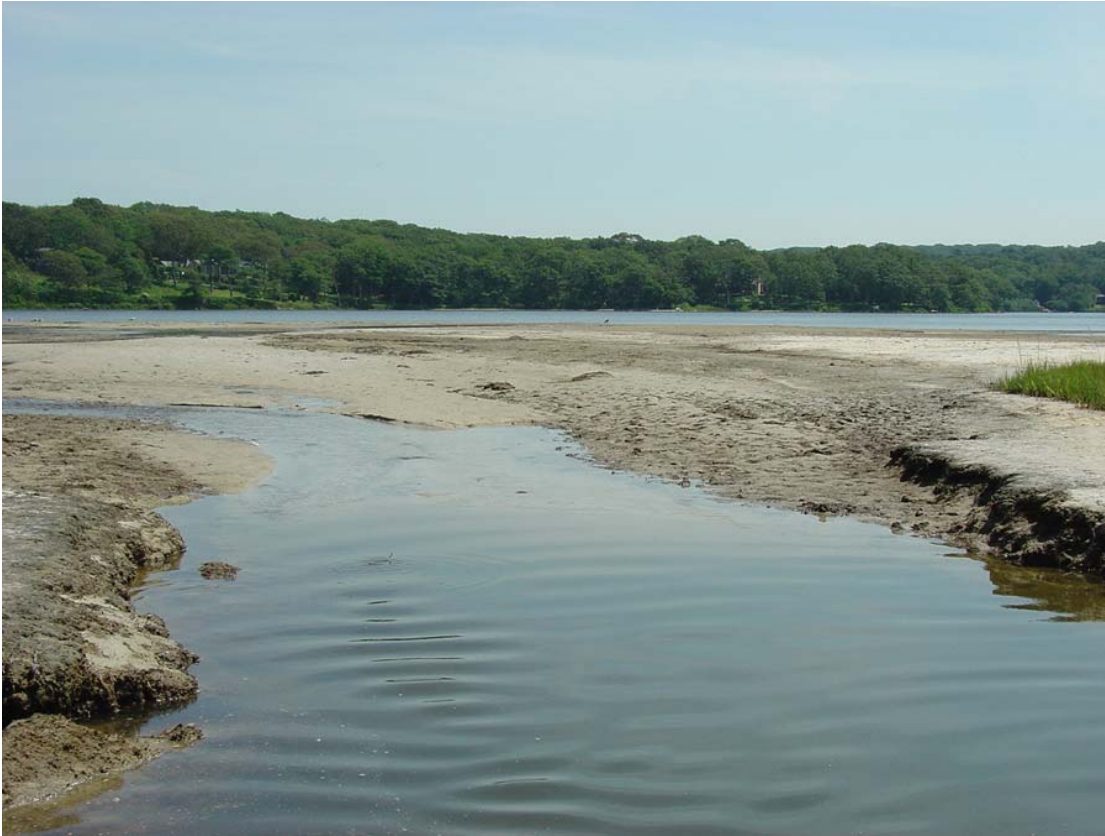
Entrance to James Pond

Herring have been reported to enter this 37 acre pond that is connected to Vineyard Sound by a short tidal stream. The stream has a history of shoaling due to beach sand deposition and must be kept open to insure passage.

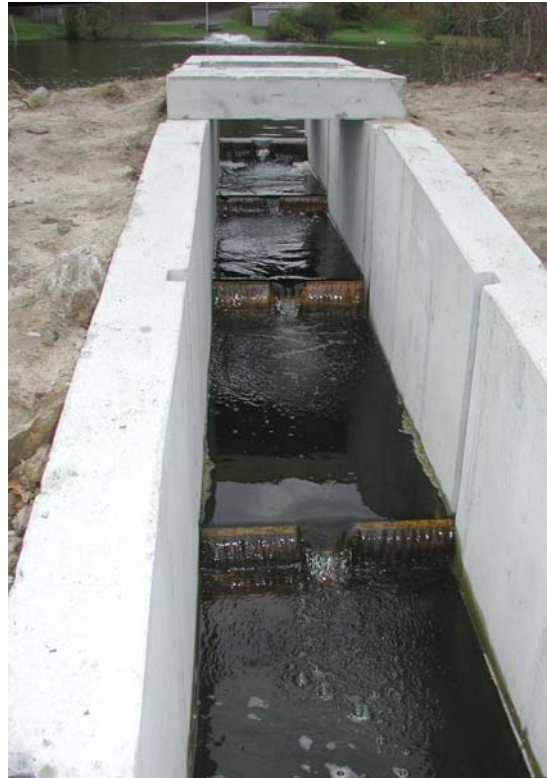
Lake Tashmoo Control Structure/Ladder

River Mile	Type	Material	Spillway W (ft)	Spillway H (ft)	Impoundment Acreage	Year Built	Owner	GPS
0.1	Dam	Concrete with wooden boards	2.5	3.8	1.3	-	Town of Tisbury	41° 26' 55.199" N 70° 37' 20.101" W

Design	Material	Length (ft)	Inside W (ft)	Outside W (ft)	# of Baffles	Baffle H (ft)	Notch W (ft)	Pool L (ft)	Condition/Function
Notched weir-pool	Concrete with wooden baffles	49.4	2.5	2.8	7	Varied (3.8)	0.6	6	Excellent Passable

Lake Tashmoo is a large salt pond which has a 1.3 acre freshwater impoundment at its head. In 2001, a fishway was designed by DMF and installed by the Town of Tisbury in order to provide passage to the impoundment. Since a small river herring spawning population already existed in the upper reaches of the salt pond, fish were observed using the new structure in the spring of 2002. It is not known if this new access to such a small spawning area will have any effect on the total population size of the system.
