Mill Brook Watershed Management Committee

Fall 2024 - Data Collection Update

12/11/2024 Select Board meeting

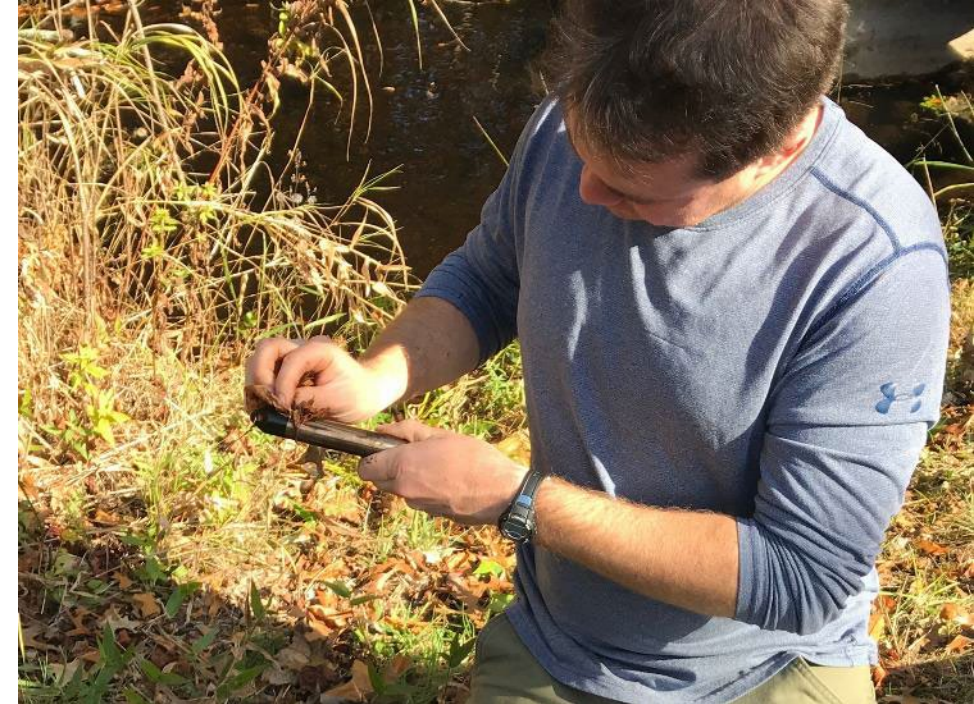
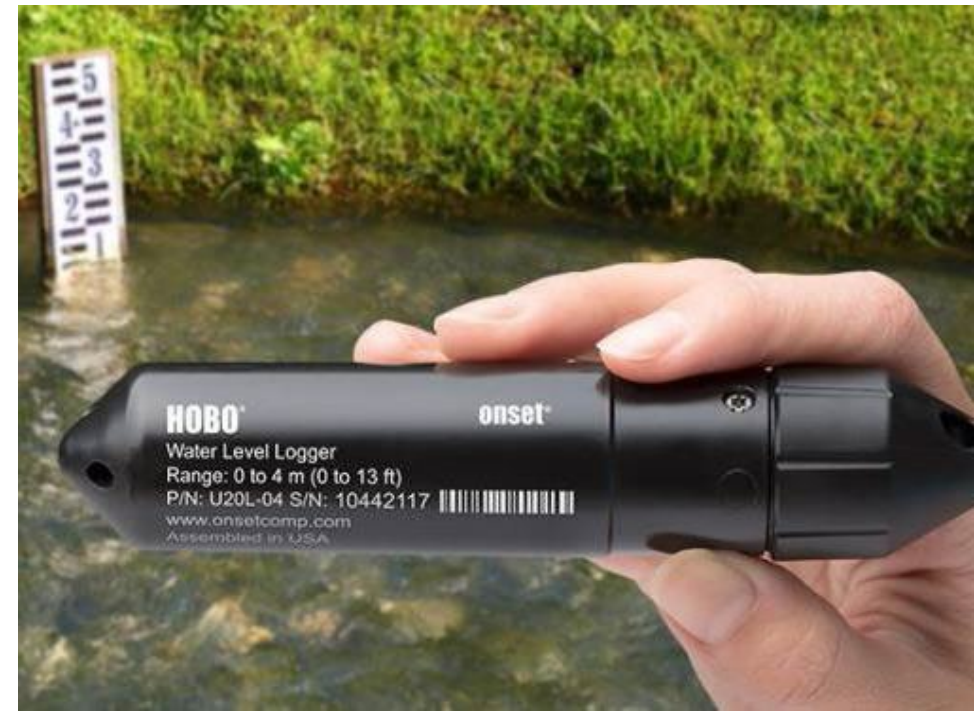
- 5 stream flow gauging stations
 - Pressure sensor continuously measured water level
 - 30 min intervals
- 30 dates from 2021-2024
 - >100 flow measurements
- In-field measurements calibrate the pressure sensors to calculate continuous flow at each location

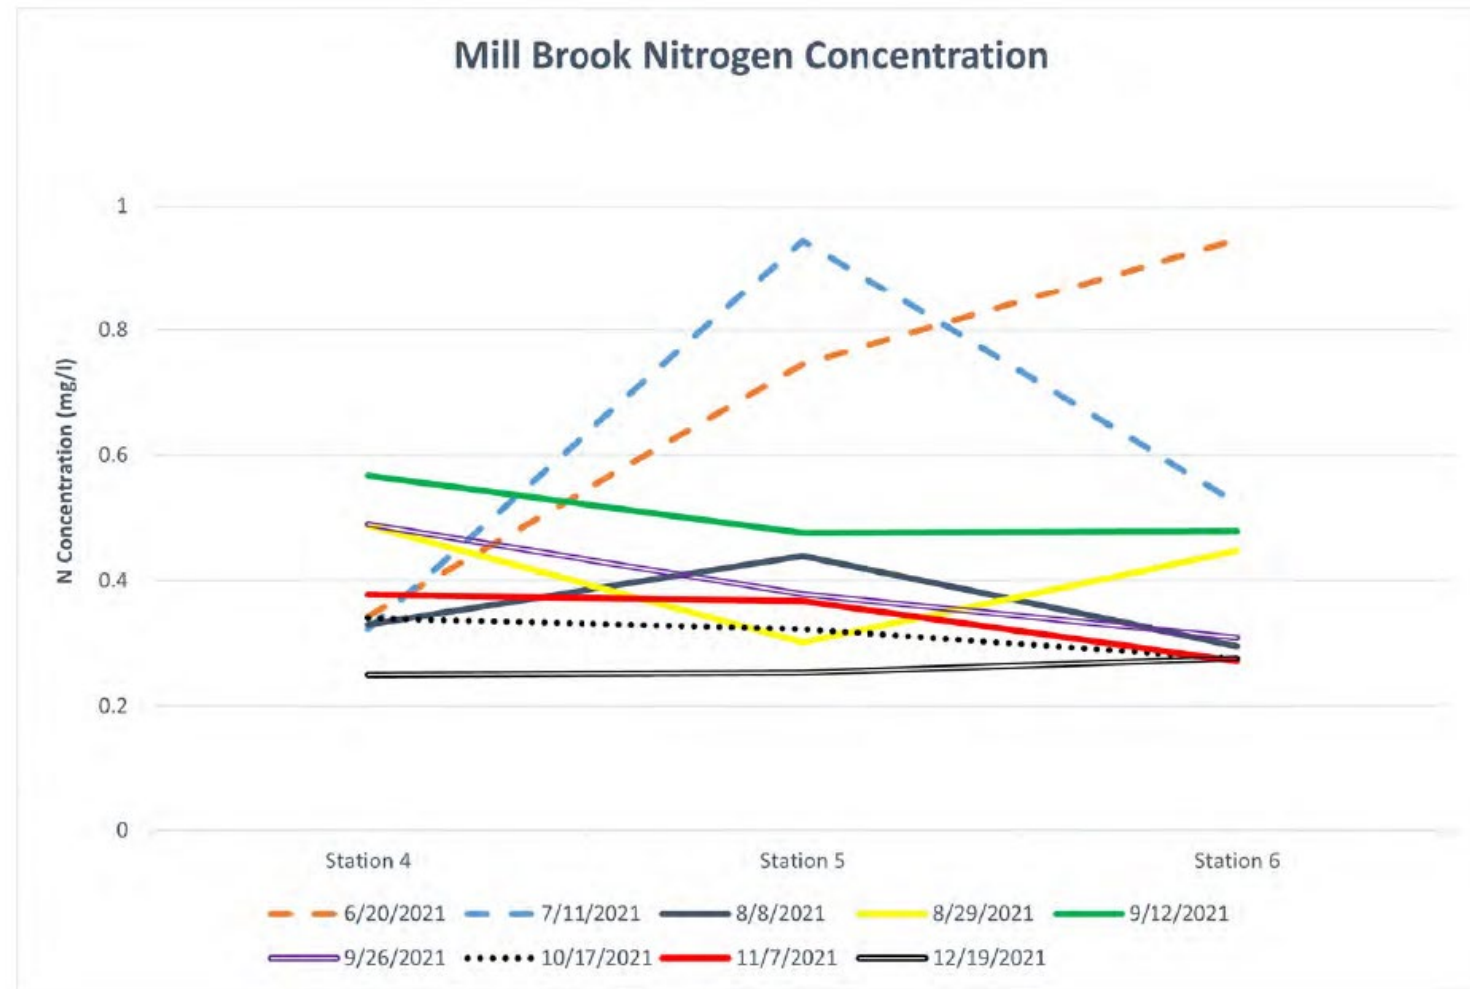
Figure 11 Mill Brook Nitrogen Concentration (mg/l)

- Data show that water quality is good
- Nutrient load calculation:
 - N= 3.054 kg/day
 - P= 0.517 kg/day
- Nutrients (N & P) are converted into excess biomass in the ponds
- Dissolved nutrients demonstrate that the system is limited by P availability
 - Total nutrients, including organic matter, indicate the system is not constrained by either nutrient

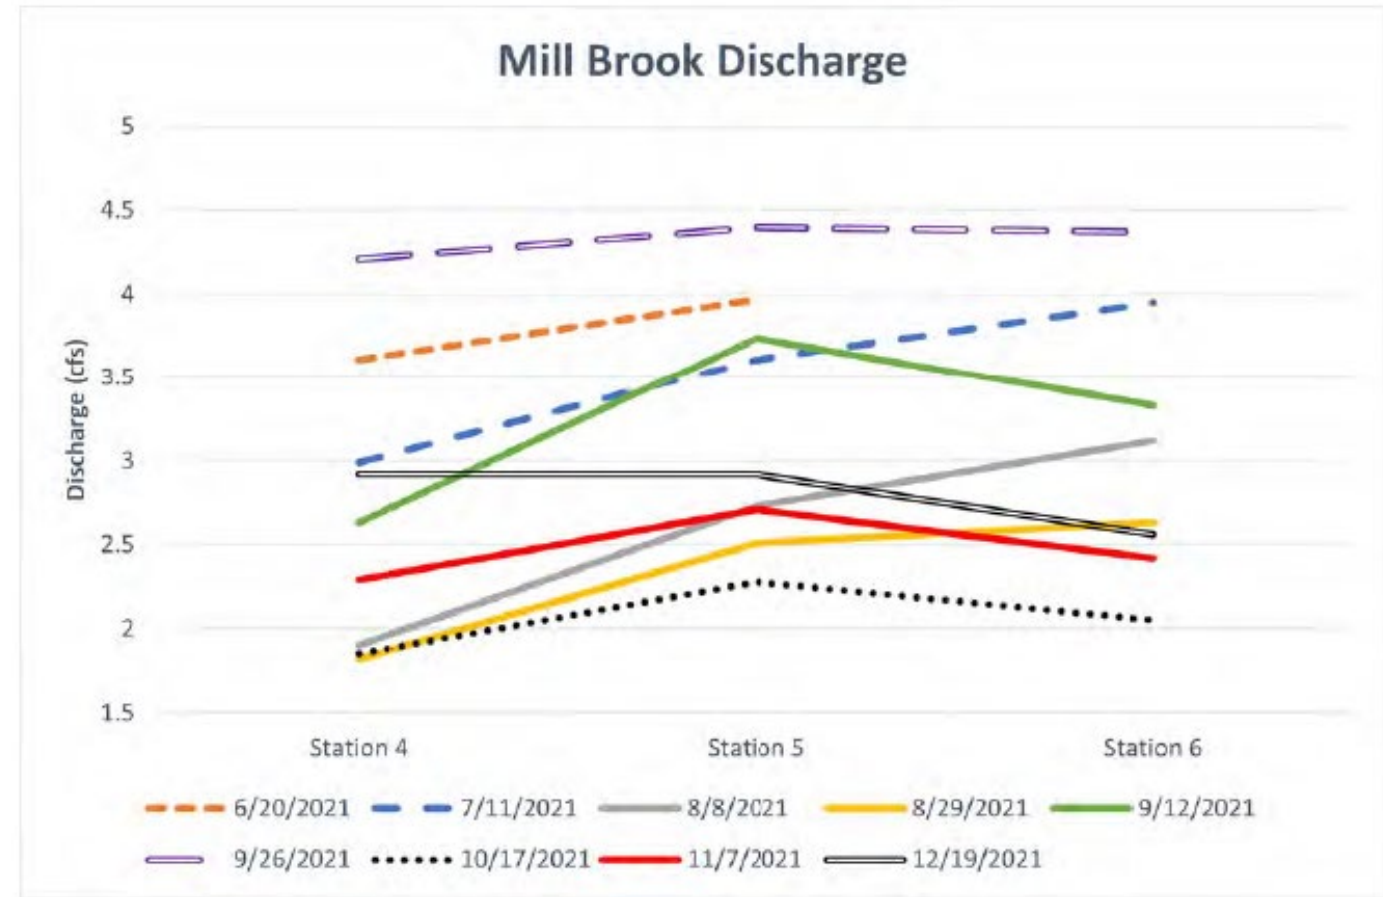
Figure 6 Mill Brook Discharge (cfs)

- Data enabled calculation of the relationship between water elevation and the volume of water flowing in the stream
- Flow increases downstream
- Flow drops below Mill Pond due to:
 - Loss to Factory Brook
 - Evaporation
 - Loss to groundwater due to elevated water head of the impoundment

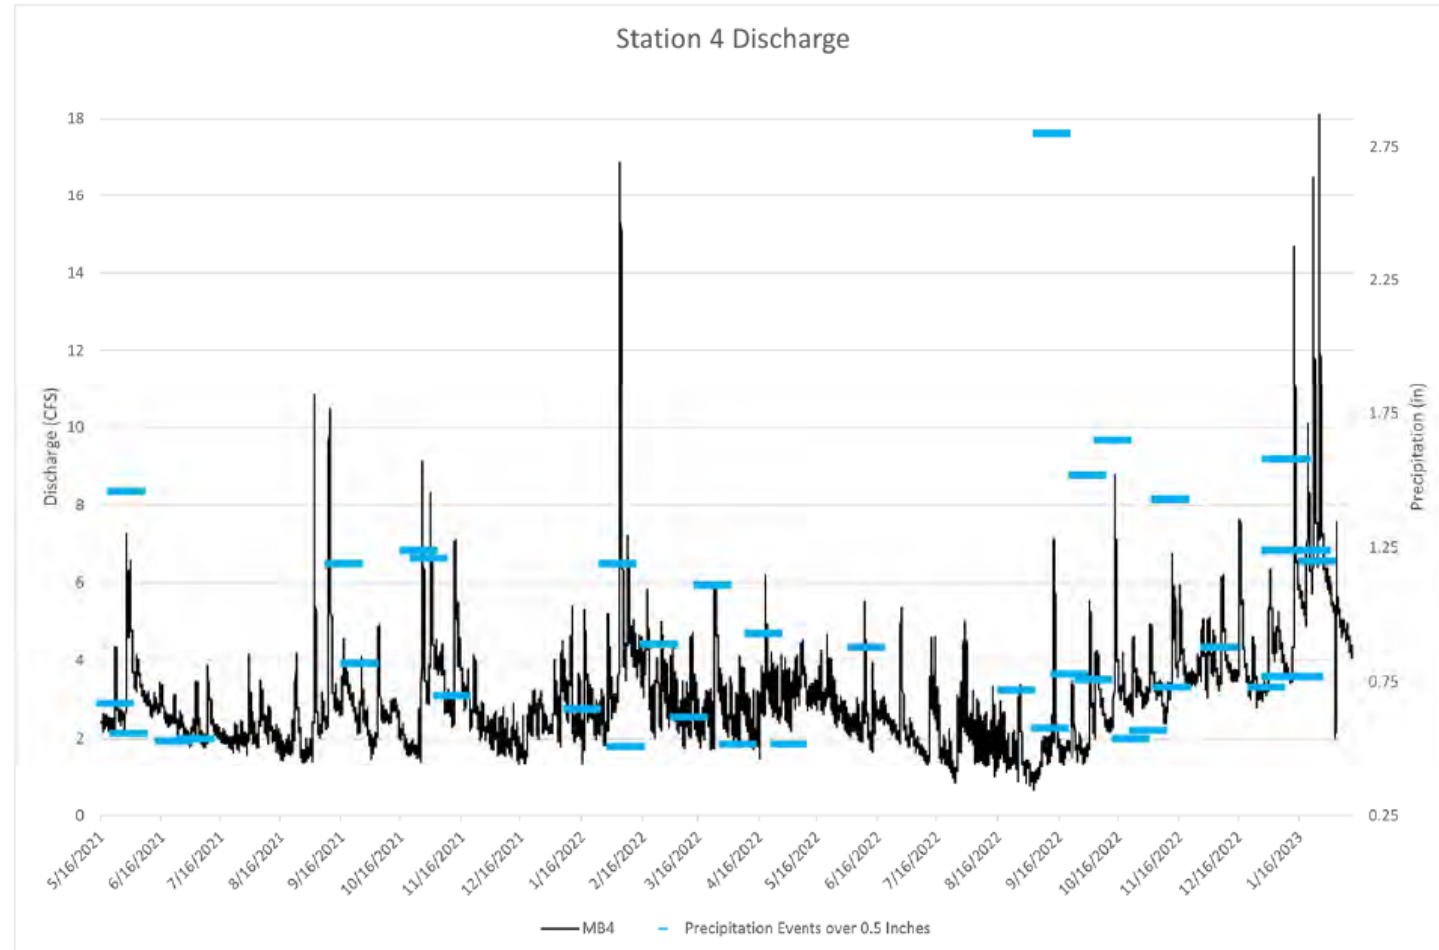
Figure 7 Station 4 Discharge Calculated from Stage-Discharge Relationship (cfs)

- Our stream flow data fits into the range of values measured over time for Mill Brook
 - Toward the lower end of the range for 2021 and 2022
- The stream responds quickly to rainfall
 - Direct response indicates the possibility of runoff from roads and lands with limited natural vegetation buffer

3. Road runoff discharges are contributing unfiltered water to the brook at Mill Pond and below Priester Pond, as indicated by the rapid response of stream flow to rain events. These sites should be further investigated to discharge runoff into upland vegetation or into infiltration basins.

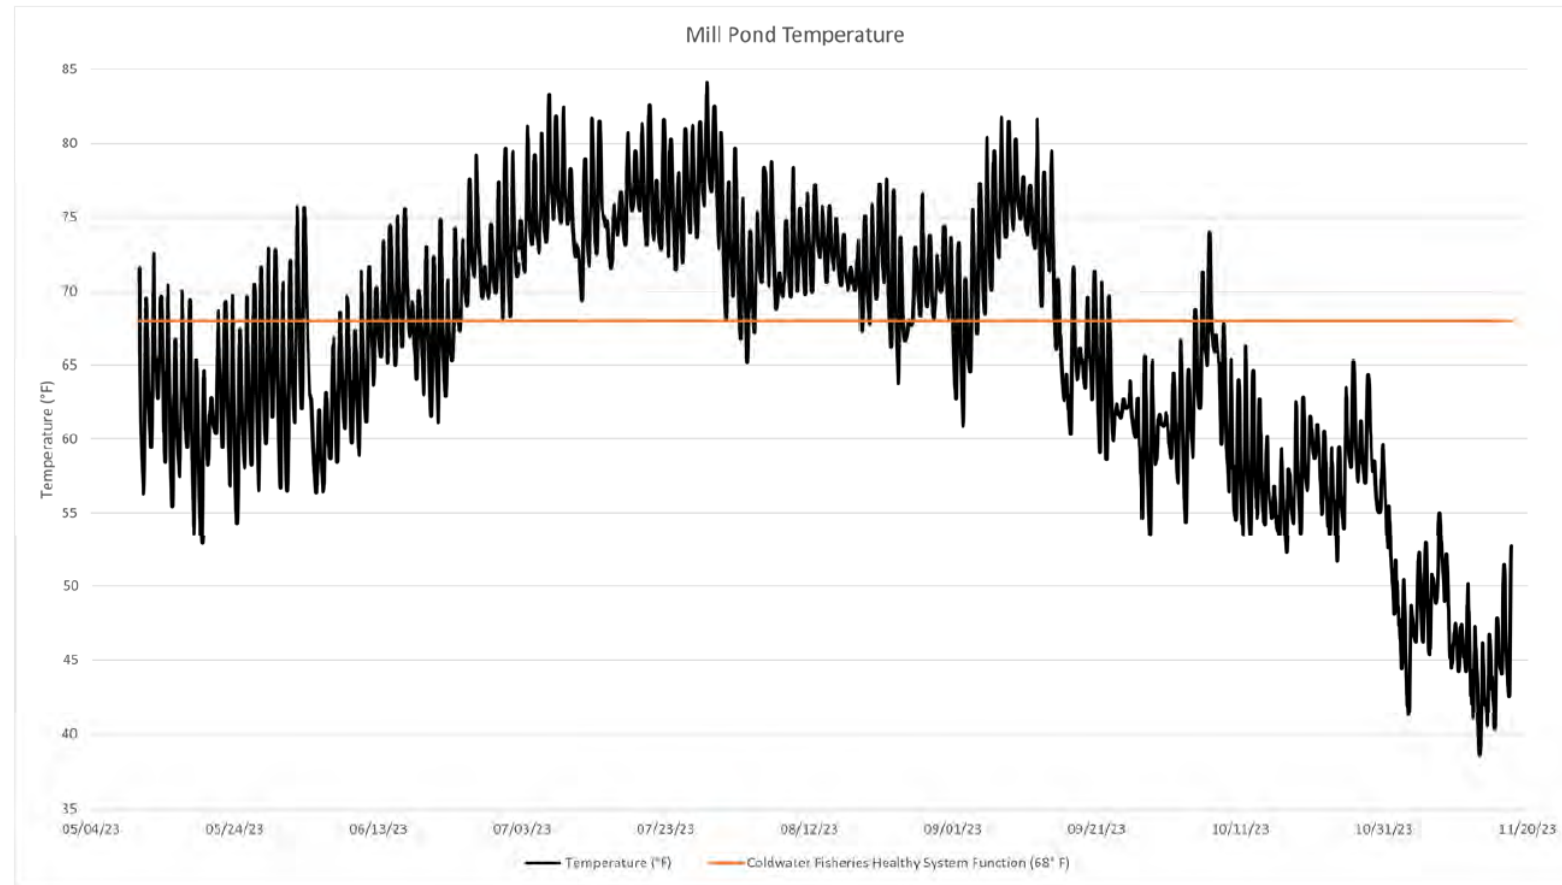
Figure 16 Mill Pond Temperature (°F)

- Maximum temperature of 84°F
- Mill Pond seasonal temperature exceeds 68° for nearly the entire period between late June and mid-September 2023
 - 68° is temp limit for cold water fisheries
 - Warming effects of impoundments persist throughout Mill Brook system
- Extremely inhospitable for native coldwater fish (brook trout and brook lamprey, a threatened species) as well as many aquatic insect species

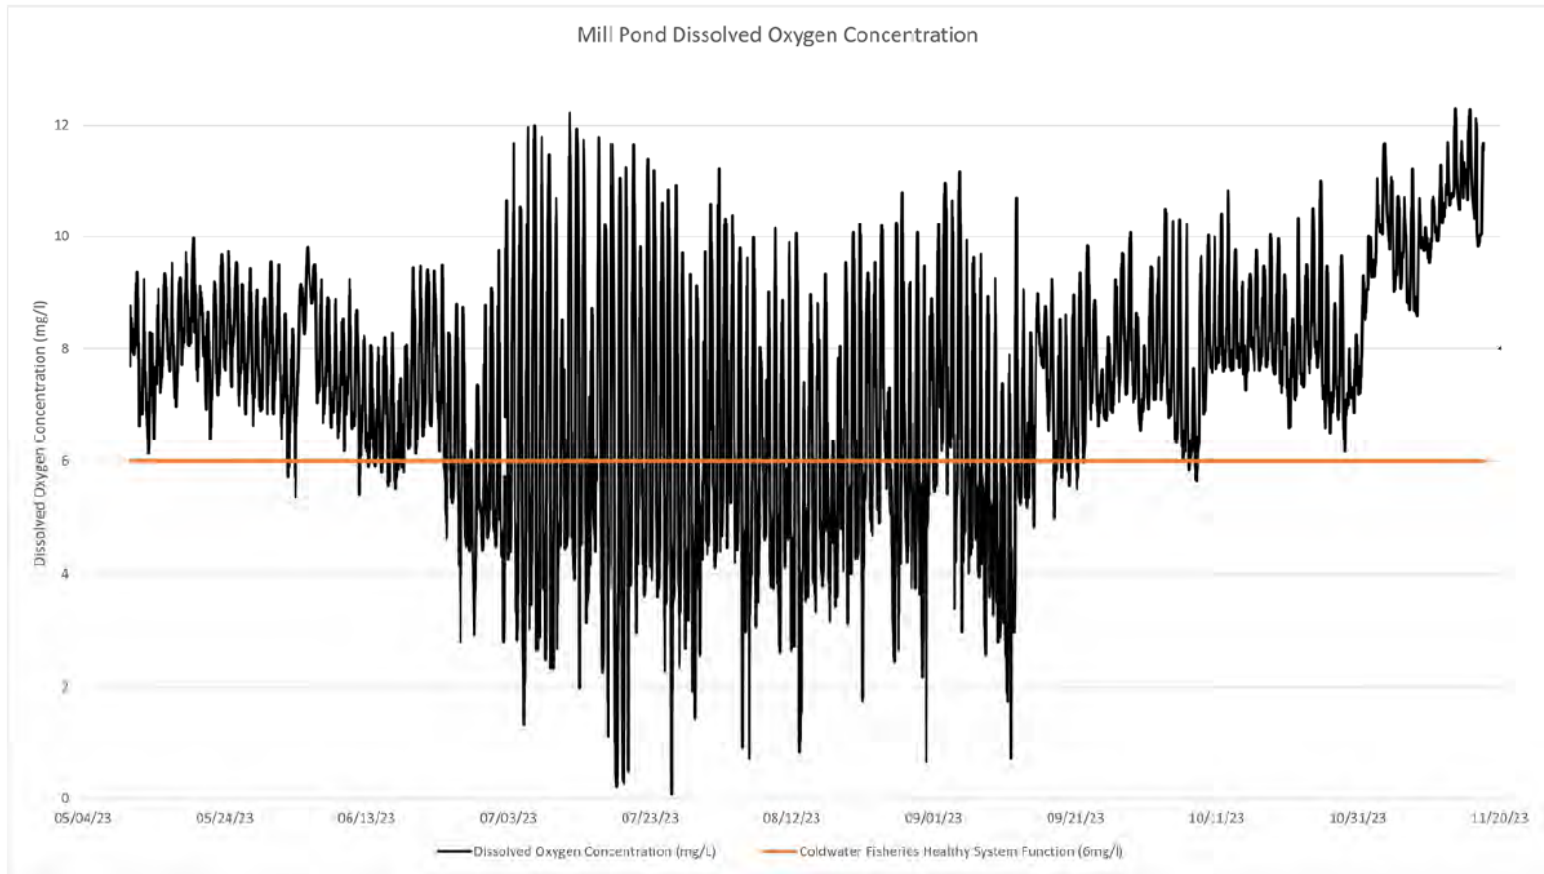
Figure 15 Mill Pond Dissolved Oxygen Concentrations (mg/l)

- Mill Pond summer dissolved oxygen is below acceptable levels one third of the time
- Levels fell below 2 mg/L numerous times overnight during 2023
- Ecosystem quality is largely determined by the period with the worst water quality regardless of what the averages are

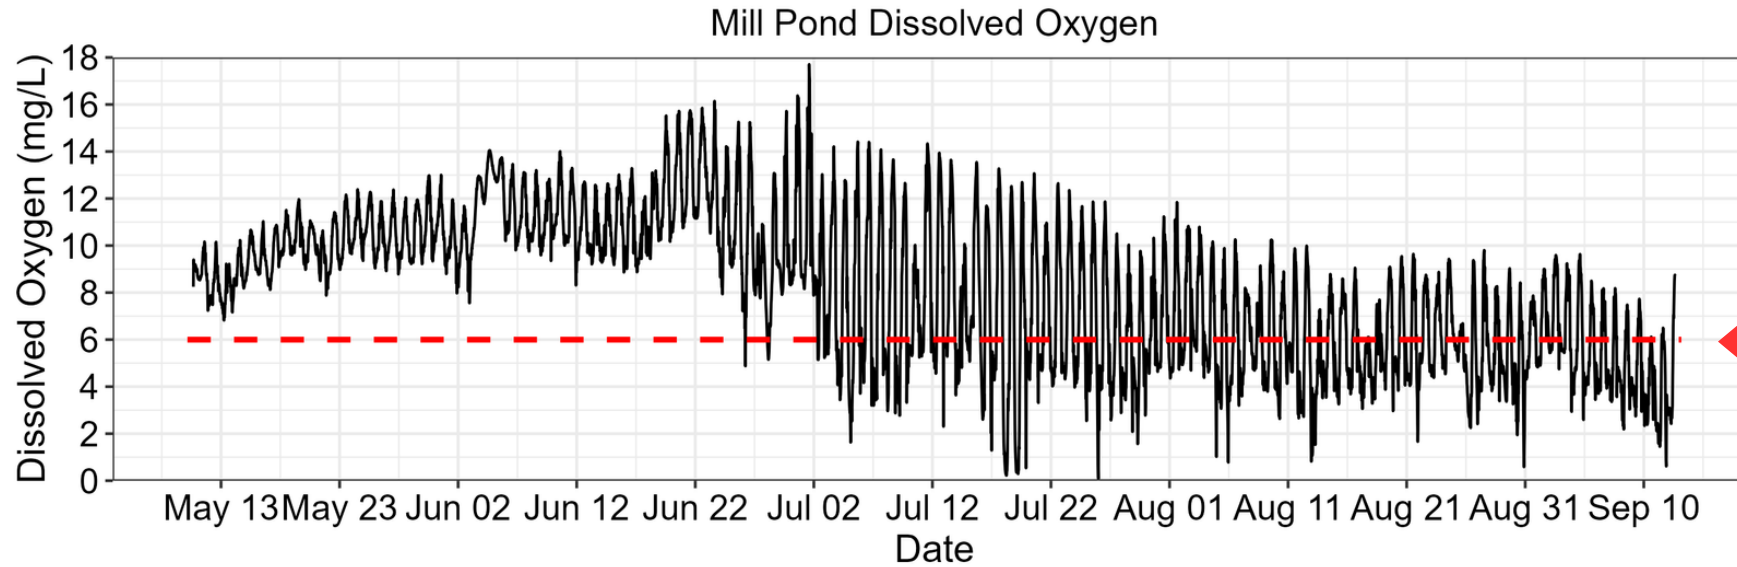
Continuous Measurements: temperature, elevation, dissolved oxygen

Massachusetts Surface Water Quality Standards for cold water fisheries:

Dissolved oxygen minimum is 6 milligrams per liter

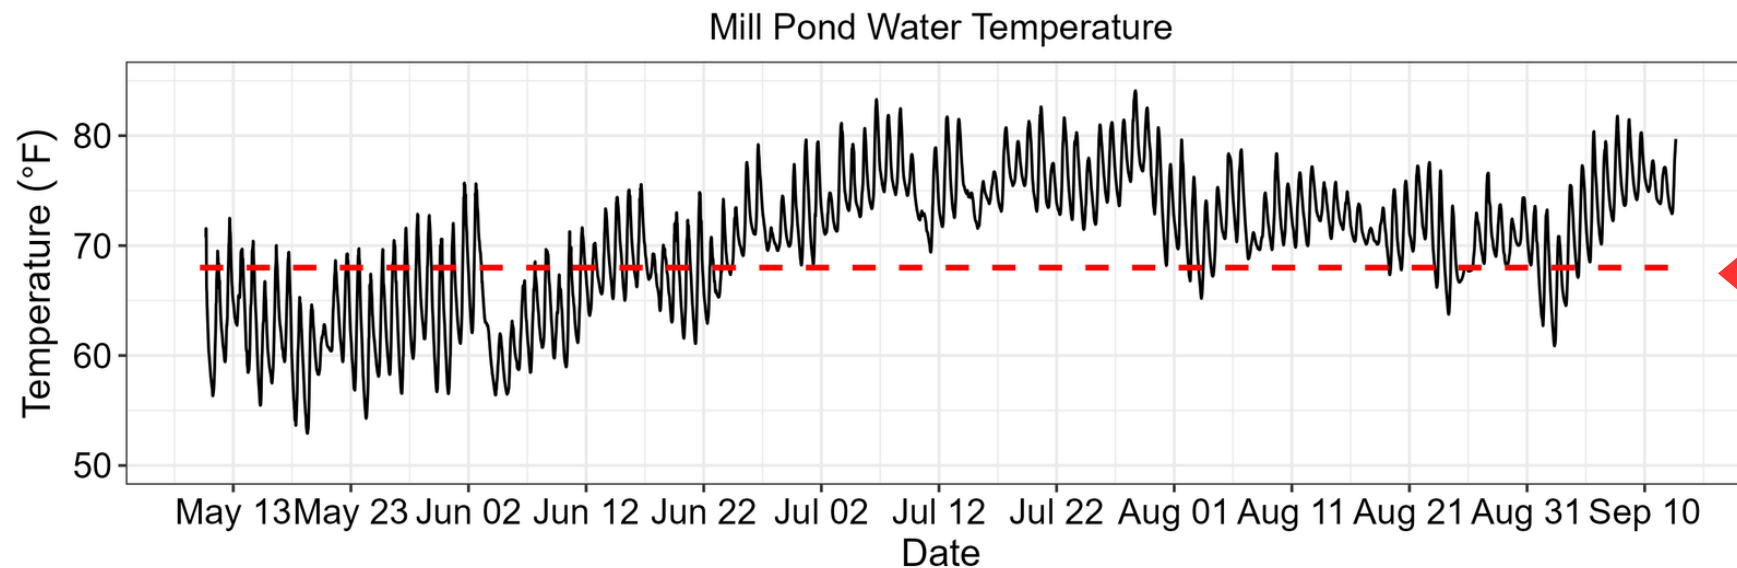
Temperature maximum is 68°F
